Manhole Inspection Summary

Manhole # S23SS1015MH

Insp Date: **3/29/07 10:58 AM**

Location Address: **7 HARVEST RD**

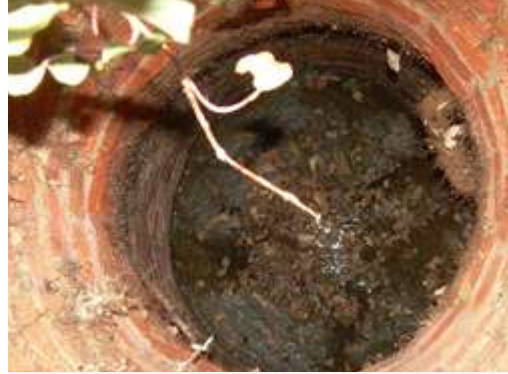
Top View

Barrel root intrusion. Channel debris

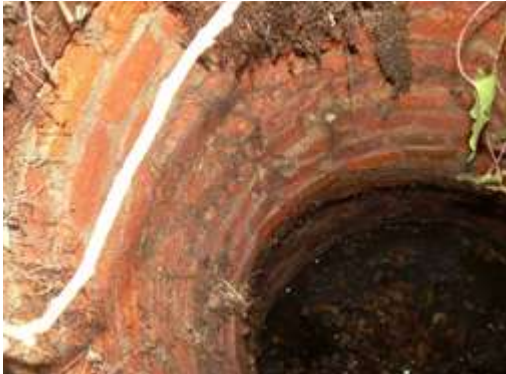
Defect

Adjustment, Corbel and Barrel root intrusion and infiltration.

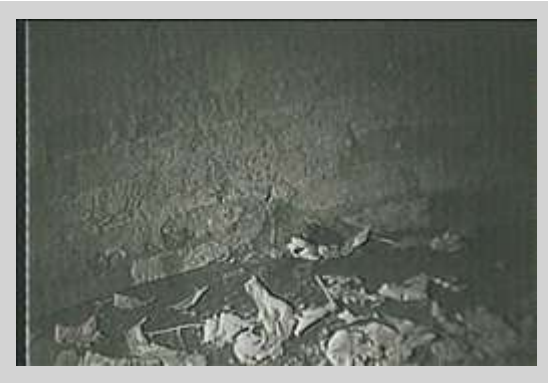
8 in. Circular Gravity Sewer Pipe Out @ 12 O'Clock

Barrel deterioration and infiltration.

Deposits: ☐ None ☒ **Mud** ☐ Sludge ☒ **Debris** ☐ Grease

Silt Depth: **5** (in.) Deposits Extent: **Heavy**

Infiltration: **None** Pipe Seal Cond: **Roots**

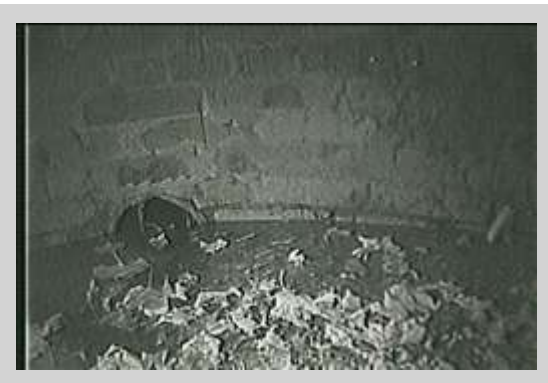
8 in. Circular Gravity Sewer Pipe In @ 6 O'Clock

Deposits: ☐ None ☒ **Mud** ☐ Sludge ☒ **Debris** ☐ Grease

Silt Depth: **5** (in.) Deposits Extent: **Heavy**

Infiltration: **Evidence** Pipe Seal Cond: **Roots**

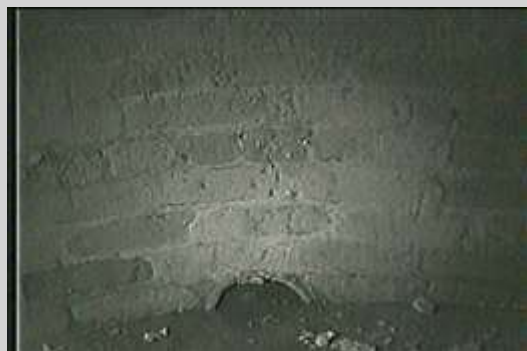
Pipe In @ 9 O'Clock

Deposits: ☐ None ☒ **Mud** ☐ Sludge ☒ **Debris** ☐ Grease

Deposits Extent: **Heavy**

Infiltration: **Evidence**
